**BULLETIN NUMBER: 101**

**SUBJECT: Intermittent Steamer Buzzer**

**MODELS: All Steamers**

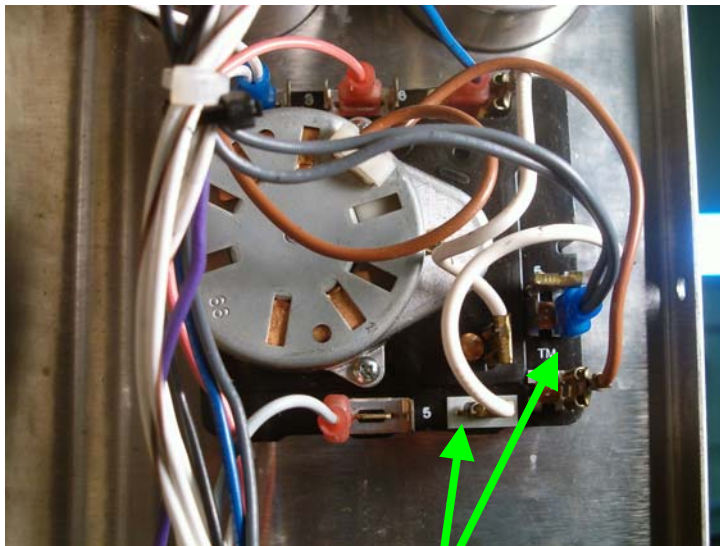
BEFORE

There have been recent instances of the steamer timer (AT0E-2297, all timer models) not sounding off at the end of a timed cycle. Investigation with the supplier revealed a wiring issue with the timer motor wiring. The root cause was that the timer motor was disabled before the timer could complete its timing sequence, resulting in intermittent buzzer operation. AccuTemp is taking corrective action steps to resolve this issue with the supplier and at its factory.

- 1) Move the gray wire pair, as shown, from the right side terminal #5 to the bottom side terminal #5 (timer shown in mounted orientation).
- 2) Move the white wire, as shown, from the bottom side terminal #5 to the bottom side terminal #4 (timer shown in mounted orientation).
